JONES, Gary A. - Van Niekerk, Kleyn & Edwards, Consulting Engineers,
South Africa.

SMITH, Andrew C.S. - Reef Lefebvre (Pty) Ltd., South Africa.

DESIGN, CONSTRUCTION AND MONITORING OF A REINFORCED EARTH WALL FOR RECONSTRUCTION
OF A HIGHWAY SLOPE FAILURE.

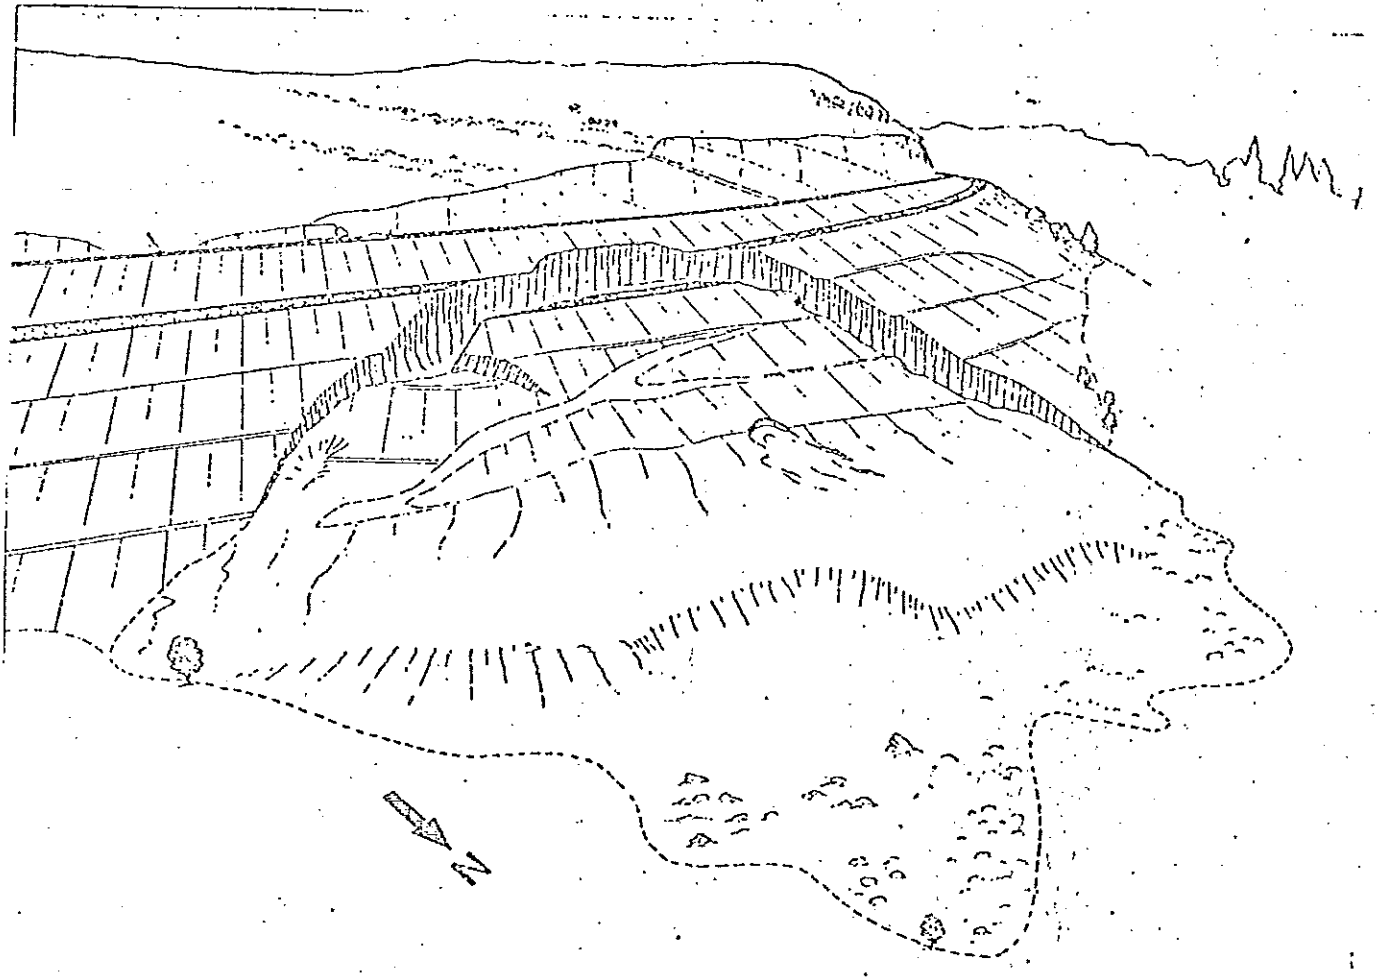
FIGURE 1. PERSPECTIVE OF SLIDE

During January 1978, after exceptional rain a section of split level dual carriageway highway on Road P39-1, near Krugersdorp, South Africa collapsed. At the failure the road was on a steep gradient as it climbs an escarpment. The road was constructed partly in cut and partly on fill, on a natural side slope of about 1 in 2. The failed section was about 80 m long and the lower carriageway dropped about 6 m. The failure zone extended about 150 m down the slope, at which point the slide debris formed a tongue approximately 200 m wide.

A view of the failure is shown in Figure 1 and a cross section through the centre of the slide is given in Figure 2.

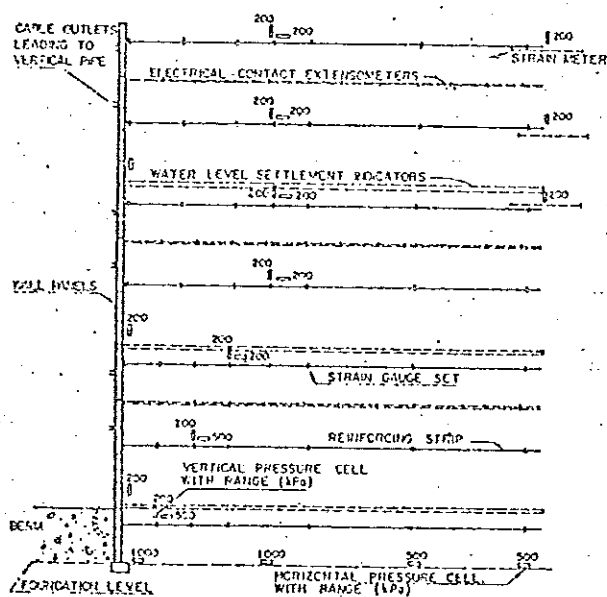
FIG. 4 SECTION SHOWING INSTRUMENTATION

conditions within the reinforced earth, and overall, referring to the performance of the structure as a whole. The structure was instrumented at a section which is 16 m high. Figure 4 shows the positions of the various monitoring devices; viz. earth pressure cells, strain gauges, settlement gauges, extensometers and inclinometers. To avoid congestion the pressure cells and strain gauge instrumented strips are offset by one panel from the extensometers and settlement devices.

be accurately measured. In order to measure deformations within and immediately behind the reinforced mass, inclinometers and water level settlement tubes were placed in the fill together with multiple point horizontal extensometers, as shown in Figure 4. Since the stability of the total mass depended on excessive pore pressures not developing in the future, piezometers were installed to carry out long term pore pressure readings.
