Design and construction of a composite nailed and mechanically stabilized embankment structure across a talus slope

ABSTRACT: A new section of road on a greenfields alignment, over grasslands and indigenous and exotic forest is under construction from the Ncembu Plateau to the Langeni Sawmill, Eastern Cape Province, South Africa. Retaining wall number 1 starts as the road leaves the escarpment and runs beneath a dolerite cliff face. The wall is founded on steeply sloping boulder and clay talus. A mechanically stabilized earth (MSE) solution was chosen for construction of the retaining wall. The contractor's hard rock source was located at the top of the escarpment and the haul road providing access to this rock source fell within the road prism of retaining wall 1. A solution became necessary to construct this wall, while keeping the haul road open to traffic. This paper outlines the solution which comprises a composite structure, combining the use of self drilling, self grouting hollow soil nails, and an MSE structure using synthetic reinforcing strips. Although this type of solution is not new, the particular circumstances on this project are unique and called for a particular s

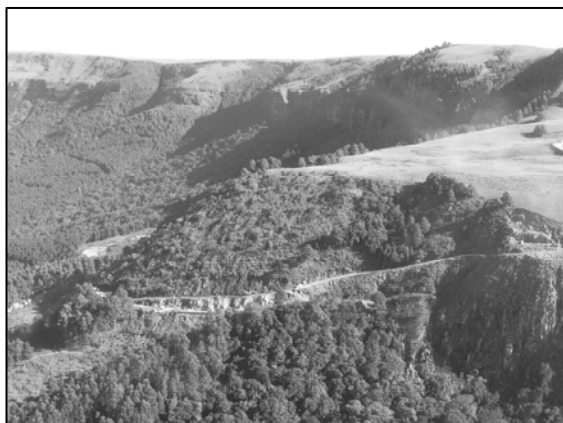
Figure 1. Road and temporary haul road crossing talus slope

The construction of a road, between the town of Ugie and the Langeni Sawmill in the Eastern Cape Province of South Africa, is presently nearing completion. This is a 110 million dollar government project to link extensive timber plantations in the Ugie-Maclear district to a large sawmill at Langeni. The final 17 kilometres of the road crosses the Ncembu Plateau, before descending the 500 metre high Langeni escarpment to Langeni Sawmill. The escarpment is dominated by sheer cliffs of dolerite, extending for many kilometers in each direction. The key to the route down the escarpment is a break in the cliff line which takes the form of a steeply sloping "nose". This is illustrated in Figure 1.

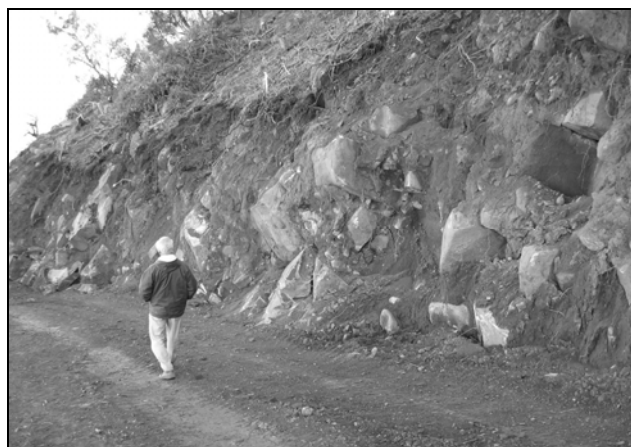
Figure 3. Cutting in talus slope

Based on the borehole core logs, the initial assessment of the proportion of boulders in the talus was 60 percent. Subsequent monitoring during soil nail installation proved that this figure was about 45 percent. Boulder size varied from small to several metres across. Figure 3 shows a photograph of a cutting through the talus and illustrates the boulder distribution.

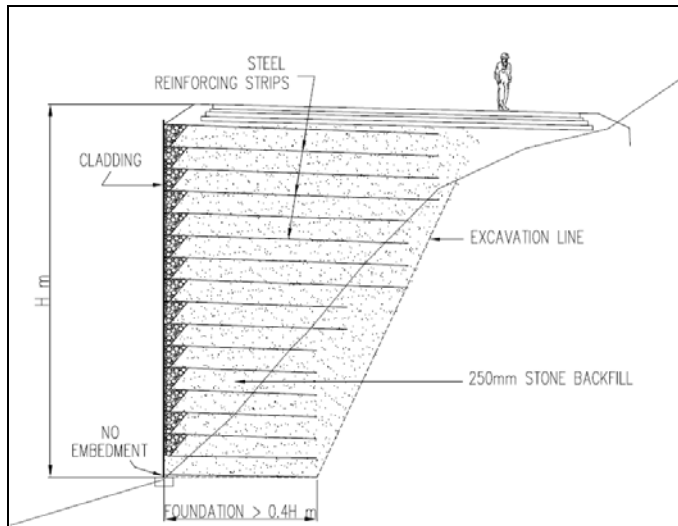
Figure 4. Cross section of original design

Wall 1 was originally designed as a standard MSE structure with cross section as shown in Figure 4.

The structure is a flexible one and is able to accommodate settlements and differential settlement. The width of the structure, equal to the length of the reinforcing strips is dependent on overall stability and economical considerations. In this case due to space limitations the narrowest trapezoidal shaped structure possible, satisfying overall sliding and overturning criteria as well as internal stability requirements, was designed. In order to further limit the bulk excavation required for preparation of the foundation the structure was designed without embedment. The boulder and clay matrix talus foundation was deemed sufficiently strong and the risk of erosion sufficiently small to eliminate the need for such embedment.

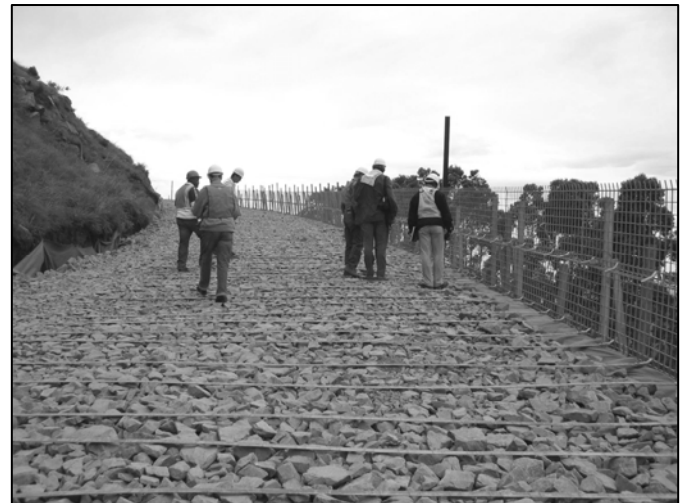
Figure 5. Original design construction

Backfill: Rockfill, with maximum size 250mm was specified for wall 1. This material eliminates the need for drainage and is easily placed in all weather conditions. The MSE backfill is defined as the volume contained by the face area of the cladding and the length of the reinforcing strips. Figure 5 shows the section of wall, unaffected by the haul road, constructed according to the original design.

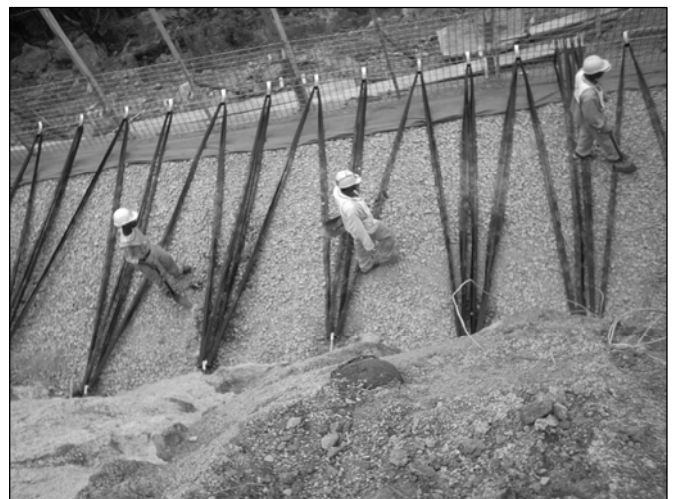
Figure 6. Placing of synthetic link reinforcement

A system of connecting synthetic reinforcing straps had been previously developed and was considered practical for use on this project. All steel strips in the standard cross section which were too long to be placed were replaced with synthetic straps consisting of discrete channels of closely packed, high tenacity, polyester fibres encased in a polyethylene sheath. The strap is supplied in a 100 metre long coil and is laced between tie points and hooks on the cladding and the yokes placed over the head of the nails. A nut was used to hold the yoke onto the nail head and to tension the link reinforcing straps between the yoke and the cladding. The density and position of the nails was determined by the density and position of the reinforcement straps which were to be attached to them. Since each nail head is attached to two tie points on the cladding, the vertical and horizontal spacing of the nails was 720mm and 1450mm respectively. The nails were also positioned on grade to match the position of the reinforcing strips.

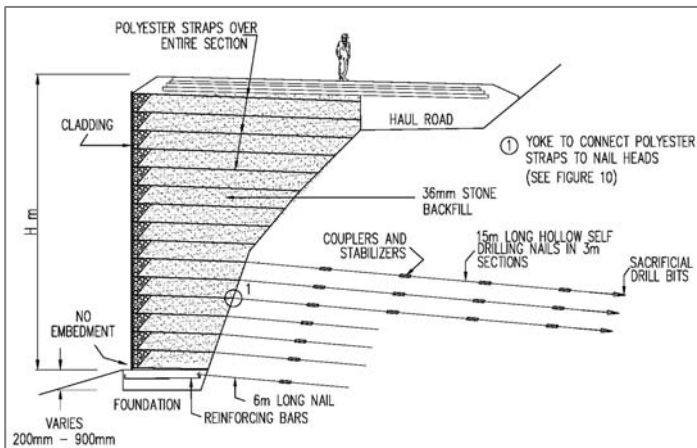
Figure 7. Typical section as redesigned to accommodate haul road and enhance the overall stability

The main constraints and components of the solution are illustrated in Figure 7 and construction is shown in Figures 8 and 9.

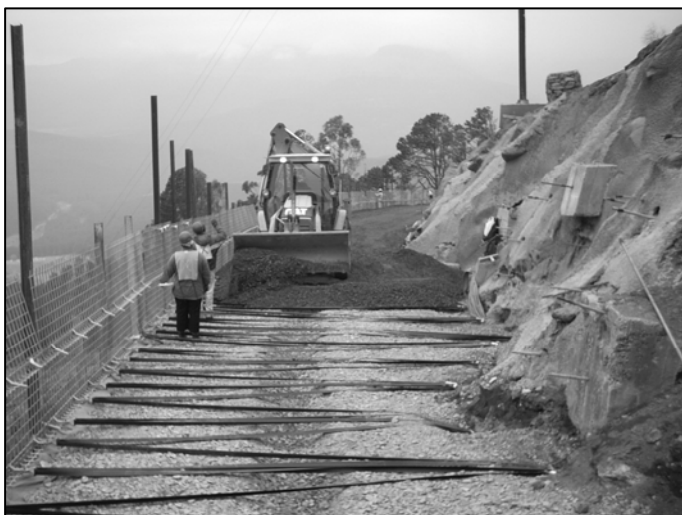
Figure 8. Construction of combined MSE / nail solution

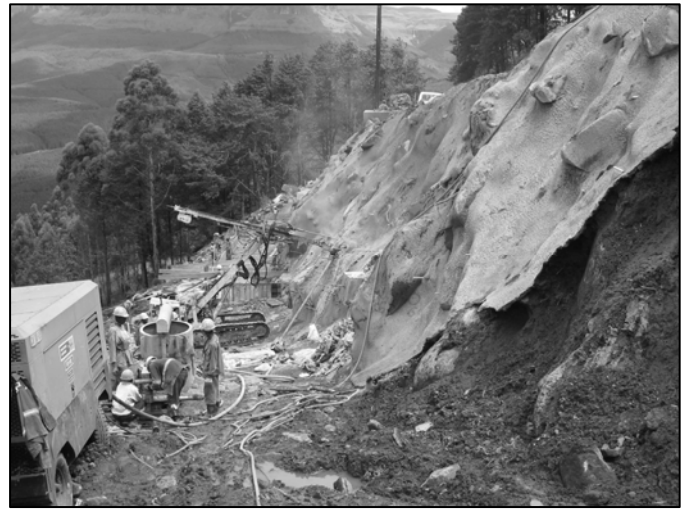
Figure 9. Installation of the soil nails

The nails: Pre-drilling and later installation of nails into grouted holes was deemed to be too onerous. Hollow self-drilling, self-grouting nails were required for installation into the massive boulder and clay talus. These nails are supplied in 3 metre lengths. A sacrificial drill bit with diameter 72mm is attached to the first 3 metre length. Additional 3 metre lengths are joined together during the drilling operation by means of couplers. A centraliser is placed at each coupler. The larger diameter drill bit and centralisers position the nail in the centre of the hole. During the drilling operation grout is pumped down the central hollow core of the nail, flows through the drill bit and back up the drill hole created by the larger diameter drill bit. Figure 9 illustrates the installation of the soil nails.

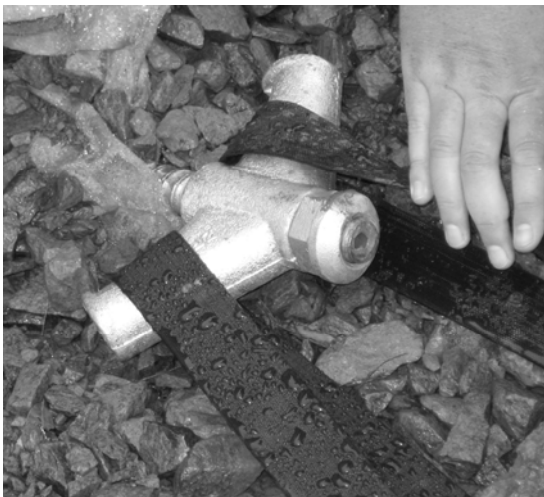
Figure 10. Connection of synthetic reinforcing strip to nail head.

The solution adopted was only developed once the construction had been underway for several months. All parties on site reacted positively to the proposed solution and this attitude facilitated its successful construction. In particular the installation of the nails to precisely surveyed positions on an unstable massive boulder and clay talus slope in a high and persistent rainfall area was a considerable challenge readily accepted by the contractor. In order to install the nails a drill rig was required and a 3 metre wide temporary shelf had to be created in front of the toe of the cut face. The average rate of installation of the nails varied from about 40 metres to 100 metres per day. A total length of 9000 metres of nail was required. Many days were lost to rain. There was also a substantial learning curve period during which a number of difficulties in the installation process had to be overcome. The nail installation period took approximately 10 months using on average 2 drill rigs. The placement of backfill, cladding and link reinforcement proceeded smoothly, the pacing item being the placement of the backfill. Figure 10 illustrates the connection between synthetic reinforcing strip and the nail head.
