# Innovative solution for a Kei Cutting problem

**ABSTRACT:** An innovative concept for the widening of fills over an existing sidefill has been implemented on the National Route 2 (N2) across the Great Kei River in the Eastern Cape Province of South Africa. Ten retaining walls have been constructed in which soil nails are combined with a mechanically stabilized embankment (MSE) to allow for the accommodation of traffic during construction, widening of the fills and compliance with overall stability requirements. This paper describes the reasons for the selection of this solution and the design and construction thereof. The cost and technical merits of this hybrid structure are compared to alternative solutions. The conclusion reached is that this solution economically satisfies the technical and environmental requirements and has potential to be used more extensively for widening projects in the future.

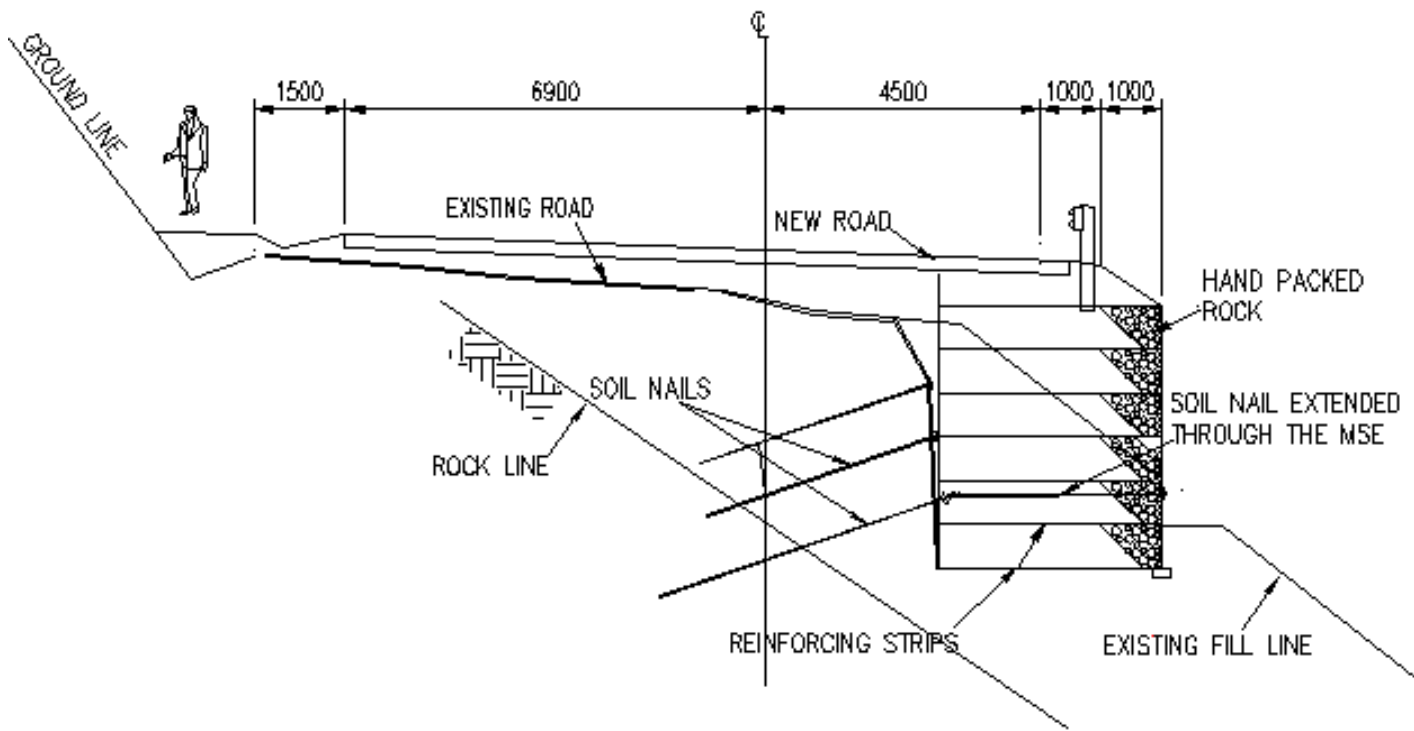
Figure 2. Typical cross section of the composite soil nail / MSE structure.

Following discussions between all parties an innovative and economical solution was proposed. This solution required a combination of a nailed system and a much narrower MSE mass. A typical cross-section of the composite soil nail and MSE structure is shown in Figure 2. This solution allows for the accommodation of two-way traffic; limits the excavation required for the MSE mass; satisfies the internal stability requirements of both the temporary nailed structure and the MSE structure, the composite nailed / MSE structure and also the overall stability requirements of the widened embankment. Finally, it provides a pleasing natural visual appearance.

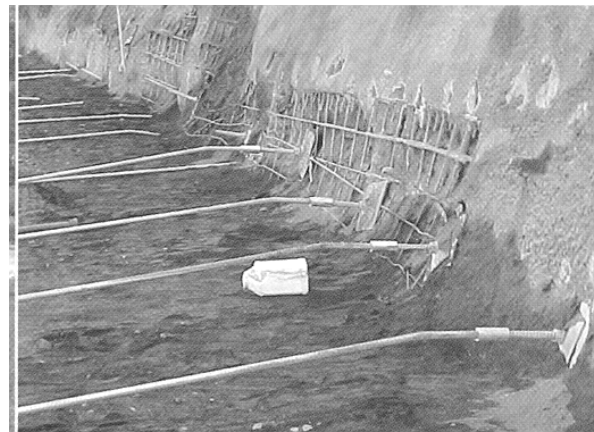
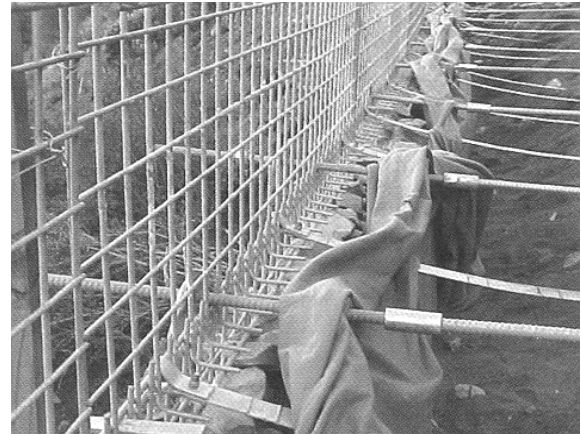
Figure 4. Detail of the nail extension.

A slip circle analysis through the nailed and MSE structures indicated that the critical slip would pass between the two structures and overall stability of the widened embankment was much the same as the original embankment. In order to enhance the overall stability of the widened embankment, it was necessary to combine the structures and this was done by extending the nails through the MSE mass. Details of this innovative nail extension solution are shown in Figure 4.

All construction takes place from behind the cladding which is a definite advantage from both construction and environmental points of view. When the level of backfill reached the first level of soil nails then the designated permanent nails were extended through the MSE mass by means of couplers, cranked nails and additional headplates, nuts and dome washers fastened outside the MSE cladding.

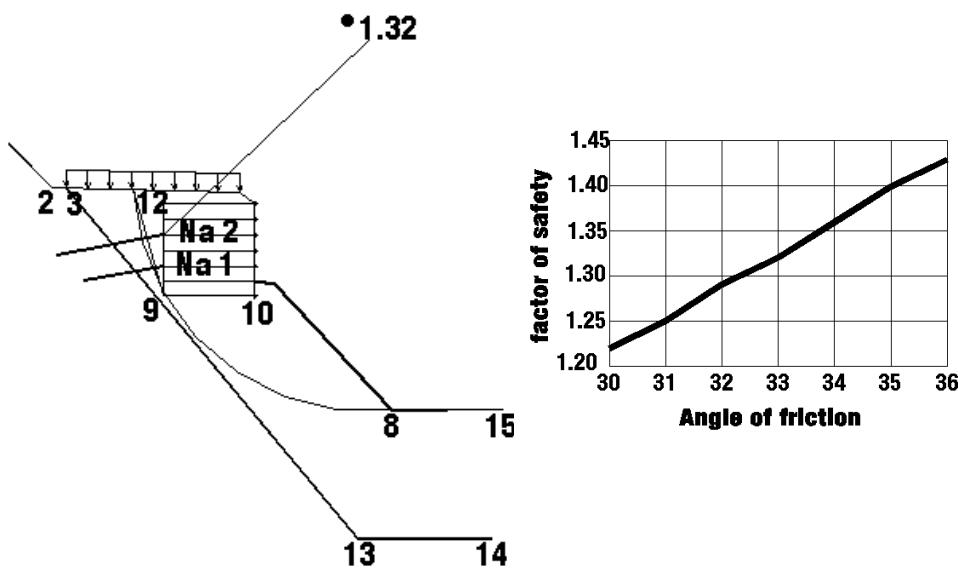
Soil no	1	2	3
$\gamma$	20	18	30
$\Gamma s1$	1	1	1
c	0	5	10
Ac(z)	0	0	20
$\Gamma C$	1	1	1
$\phi$	36	33	30
$\Gamma \phi$	1	1	1
qsNail	20	50	180

Units : kN meters and degrees  
Calculation method : Bishop1

Figure 5. Overall stability analysis for 4.4 m high MSE structure.

An example of the analysis of the overall stability of the road where the retaining structure is 6 panels or 4.4 m high is illustrated in Figure 5. Two layers of soil nails, spaced at 1.7m horizontal intervals, have been provided at this section. The reinforcing strips are 4.0m long, with the number of reinforcing strips per 3m width of wall varying between 3 and 5. Figure 5 gives the factors of safety for overall stability

of this typical section for values of the angle of internal friction ( $\phi$ ) ranging from  $30^\circ$  to  $36^\circ$ . The factors range from 1.22 to 1.43, indicating that it is stable. Since the original slope of the ground beneath the road was only marginally stable the adopted solution has improved the overall stability of the existing embankment in the vicinity of the retaining structures.

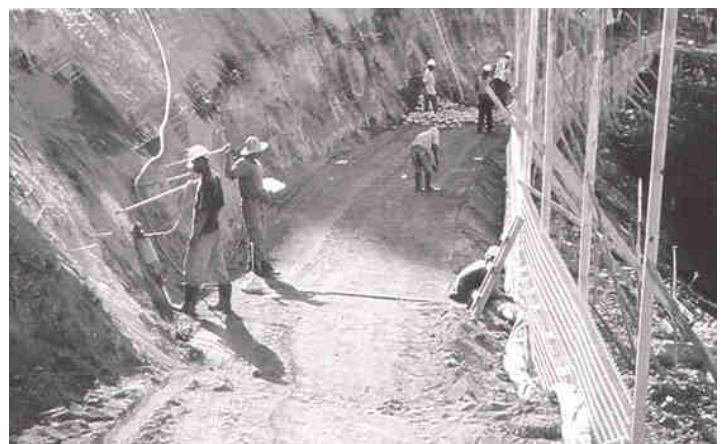
Figure 7. MSE construction and nail extension underway.
