# Backfill materials for Mechanically Stabilized Earth (MSE): African Experience

Andrew C S Smith

### ABSTRACT

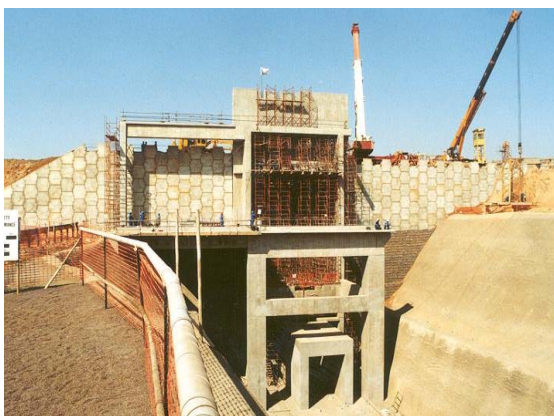
The structure is a 30m high tip wall placed 15m below natural ground level and 15m above natural ground level. The backfill used below ground was residual felsite (very fine grained volcanic rock) with 16% less than 20 micron. The above ground backfill was hillwash with 25-30% passing the 20 micron sieve and friction angle ranging from 27.7 to 32.5 degrees. Post construction settlement of the upper part of the structure bearing on the lower structure is almost linear and is ongoing. Settlements of the order of 30 mm per year occurred between 2000 and 2006 with little sign of slowdown. These settlements have caused movement in the cladding, but do not effect the overall integrity of the structure. (See Figure 1)

Figure 1. Cru-Klipfontein tip wall

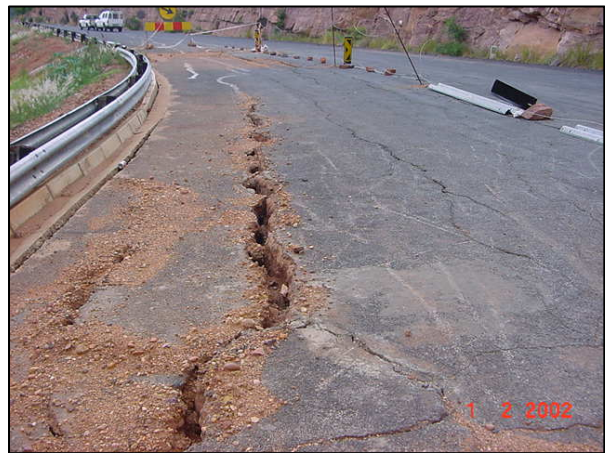
The backfill properties were those of an intermediate backfill with 20-30% less than 20 microns and angle of internal friction of the order of 36 degrees for both rapid and slow saturated shear tests at 93% Mod AASHO. Construction was almost complete when a severe rainstorm struck the site and ingress of water into the MSE mass led to progressive collapse settlement,

which is defined as the additional settlement and stress changes that a soil undergoes when its moisture content increases. It is postulated that the clay bridges in the inadequately compacted backfill collapsed as they became saturated and progressive failure of the MSE ensued (Figure 2). Piles have subsequently been driven through the failed MSE embankment and support bridge decks replacing the approach embankments.

Figure 2. Kloofpass bridge approaches

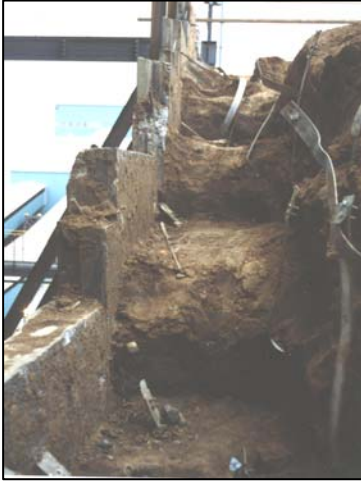
Aeolian soils of the interior, are sandy soils which have undergone redistribution by wind action and cover almost half of Southern Africa. Grading envelopes of these sands may be uniform except for varying amounts of clay. They could well be intermediate with clay content above 20%. When used in MSE structures care should be taken to compact the backfill adequately to prevent future collapse settlement. Figure 4 shows failure of an MSE structure in Limpopo, South Africa, due to inadequate compaction and subsequent collapse settlement.

Figure 4. Grootegeluk

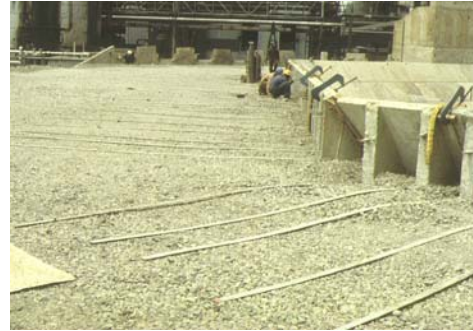
Blast furnace slag has been successfully used on 3 contracts: Faerie Glen, constructed in 1980; a structure inside the Iscor Steel Works Pretoria, constructed in 1978; a storage structure at Iscor Vanderbijlpark, constructed in 1983. The properties of the slag were consistent with pH 10.7, chloride content 35ppm and sulphate content 1680ppm. The material is an even-graded free draining gravel with 100% passing 70mm and 5% the 0.075. The electro-chemical properties fall outside the standard specifications for steel reinforcements. Sample strips were placed in the Faerie Glen backfill during construction in 1980 and extracted 14 years later in 1994. Tests showed only a small loss of zinc and no measurable loss of strength. This was also the case for test strips extracted from the Vanderbijlpark structure in 1995 after 12 years. These excellent durability results are attributed to the free draining nature of the backfill. (See Figure 5.)

Figure 5. Vanderbijlpark

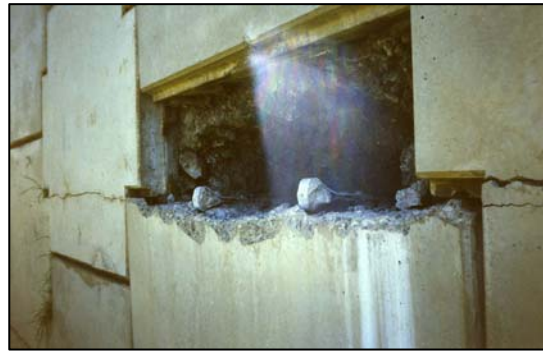
In 1998 however, RESA was alerted to cracking of the panels. Investigation determined that the problem arose because of expansion of the backfill caused by reaction of lime in the fill to ingress of water. The overall structural integrity of the structure is not affected, but the cracked panels are unsightly and ongoing repairs are necessary. The use of expansive backfill cannot be entertained in MSE structures and the material is not recommended. (See Figure 6.)

Figure 6. Dunswart

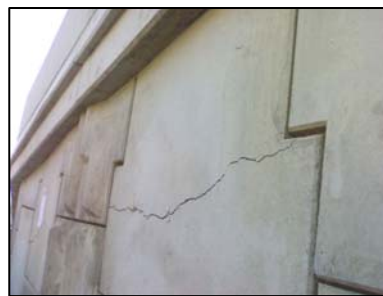
RAP was taken as backfill on the Western Freeway Durban structure constructed during 2006. The internal angle of friction was 30° degrees. 100% passed the 20 mm sieve and zero passed the 75 micron sieve. The interlock of the binder coated aggregate fragments are subject to significant residual viscous behaviour resulting in time delayed post construction creep and consolidation of the fill. In the case of the Western Freeway this led to rotation of the crash barrier during the construction process and consequent bursting of the cladding. The settlement of the fill was monitored and once it became negligible the cracked panels were repaired and the structure was brought into service. RAP, mixed 50:50 with sandstone has been successfully used on another project. RAP should not be used on its own however and should be mixed with approved backfill for use as backfill in MSE structures. (See Figures 7 & 8)

Figure 7. Western Freeway, Durban

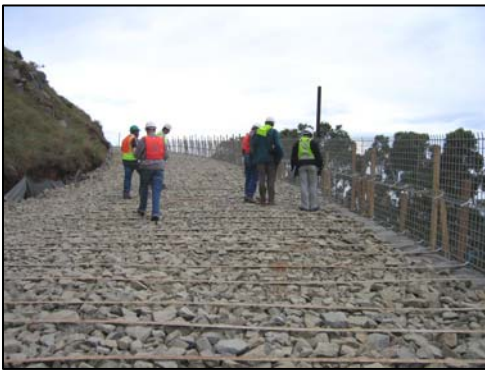
Single sized rock or stone resistant to weathering is an ideal backfill material for MSE structures. This type of material is free draining, construction can proceed in all weathers and the need for subsurface drains is eliminated. Compaction is not necessary and the material can be used to backfill areas inaccessible to compaction plant. It could also be used for backfill of structures in or under water. On the Ugie to Langeni Road (E Cape, RSA) rockfill has successfully been used with galvanized steel reinforcing strips, while 50mm stone was used with synthetic reinforcing strips.

Figure 10. Langeni –galvanized steel reinforcing strips

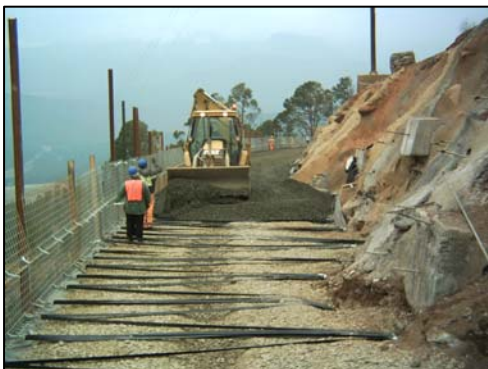
Figure 11. Langeni – synthetic reinforcing strips
